BOAT BASIN BULLETIN

Issue 9

ICE

This is the first issue of BULL dedicated to one topic: ICE – Past, Present and Pfuture.

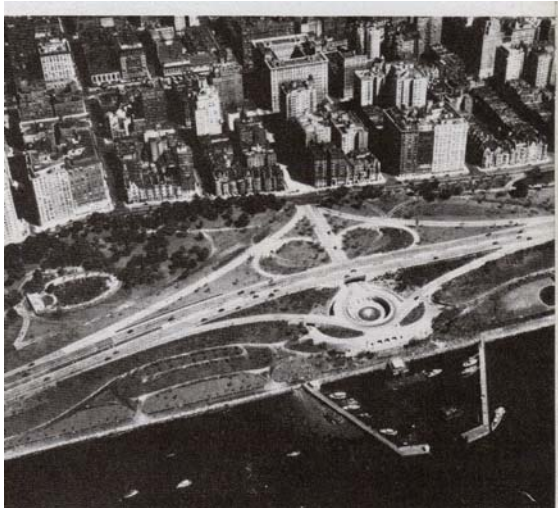
Original ice protection

When the City built the Boat Basin in the 30's, they designed it well by angling A Dock and C Dock to divert the ice. Ice breakers were then installed north of A to relieve the force of the ebb flow of ice from upriver and grounded derelict barges were set at an angle south of the Basin to relieve the force of the flood flow of ice.

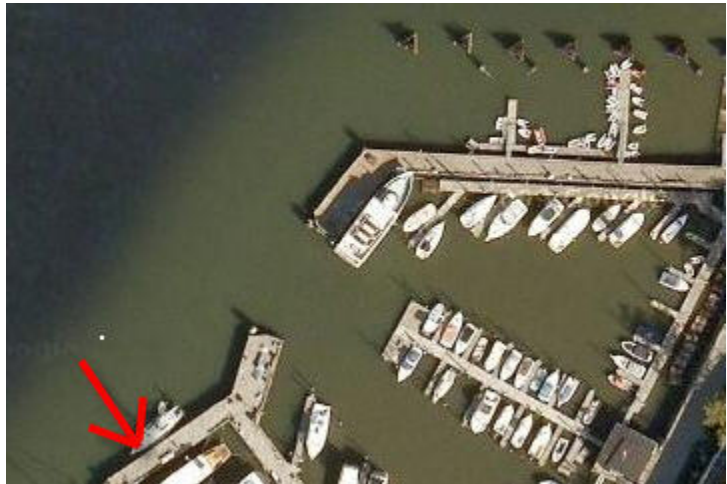
C Dock head extension

When the head of C Dock was extended (red arrow), it was extended to the southwest rather than parallel to the C Dock head, the shoreline or to the ice flow, presumably to maximize the number of slips on the south side of C dock. The southern end of the extension was located outboard of the last ice breaker. Strong ebb ice flows have smashed the facing planks at the southern end of the extension several times and the extension had to be strengthened a few years ago.

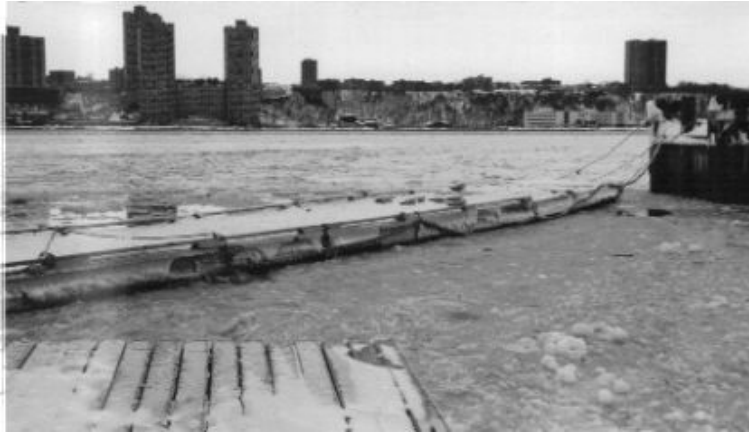
D and E floating docks added

The floating D and E Docks were added to the Basin. The gaps between E and D and between D and the C Dock extension were plugged during the winters with floating docks and the A-C opening was plugged with high freeboard camels.

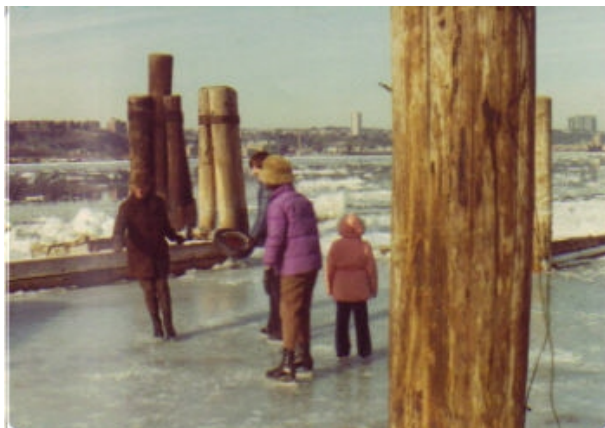
Since then, the Basin does freeze over during a long cold streak and one can occasionally walk between the docks on the ice. There has been no damage to hulls or infrastructure from the internal ice.

In 1978, residents skated between D and C Docks.

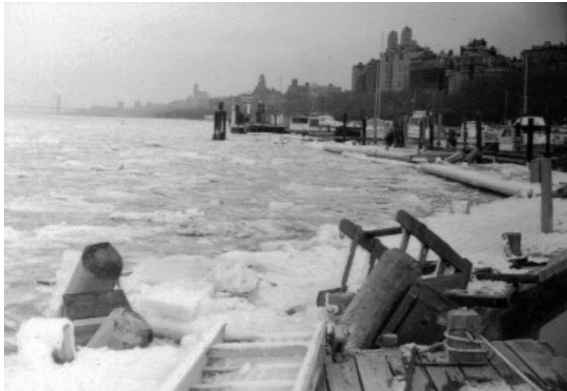
Floating docks T's

In the early 1970's, T's were built on the ends of D and E Docks with camels plugging the openings but in 1977 and 1978 the T's and dolphins were partially destroyed by strong ice flows. There is nothing like the sound of wood being smashed and splintered by ice at three in the morning to get your attention. Notice the dolphin south of the C Dock extension – it anchored the northern end of the D Dock T. The boat on the right, my "Grok", was saved by the community moving it from the first slip to the third slip on the south side of D Dock.

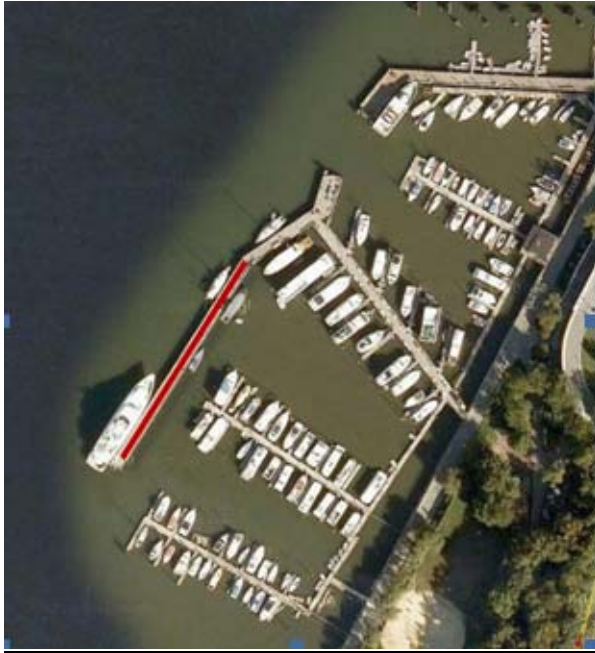
Wave wall

The wave wall was built in the late 70's to protect D and E from the ebb flow of ice. Camels plugged the southern entrance between the E Dock T and the wave wall and the northern entrance between the heads of A and C.

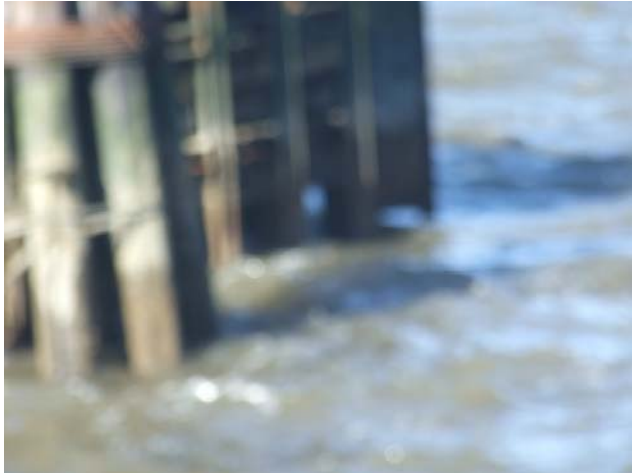
Ice breakers

When the A Dock ice breakers were replaced in the 70's, the replacement ice breakers were installed with peeler rails near the MLLW (Mean Lower Low Water) mark, the lowest level in most tide tables. The maximum ebb flow of current and ice occurs near low tide at the Basin since the ebb current begins over 3 hours before low tide and the maximum flow is halfway through the tide cycle.. If a winter spring tide and a strong W to N wind combine, the ice is pushed to the NY side of the Hudson, a wind - assisted extreme low water (NOAA calls it the Lowest Observed), occurs and a very strong ebb current runs downriver. The strong ebb flow of ice floes hits the ice breakers below the peelers (see the daylight on the right side of the photo) at maximum velocity.

At Lowest Observed, the ice is stopped by the mud (mud line runs from the second slip near the head of A Dock upriver to the point where the highway is closest to the river), sparing the inboard ice breakers. Thus, the two outboard deep water ice breakers bear the brunt of the diverted ebb ice flow at its maximum velocity.

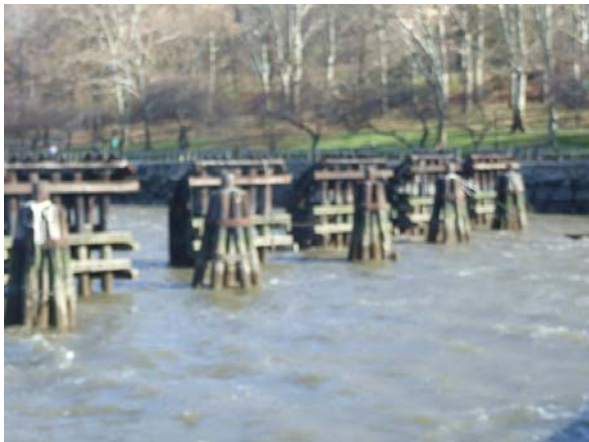
In February, 2004, the two outboard icebreakers that divert ice from the head of A Dock and the C Dock extension were bowled over by medium-sized ice floes on a medium-flow current day. The ice had hit the breakers below the peeler rails, lifted the icebreakers and snapped off the icebreakers' wood pilings. Before the ice breakers were replaced, many facing planks on the head of A Dock and on the north side of A dock were swept away and the just-repaired facing planks on the C Dock extension were crushed again. Parks repaired the extension again and strengthened the local whalers and internal structure.

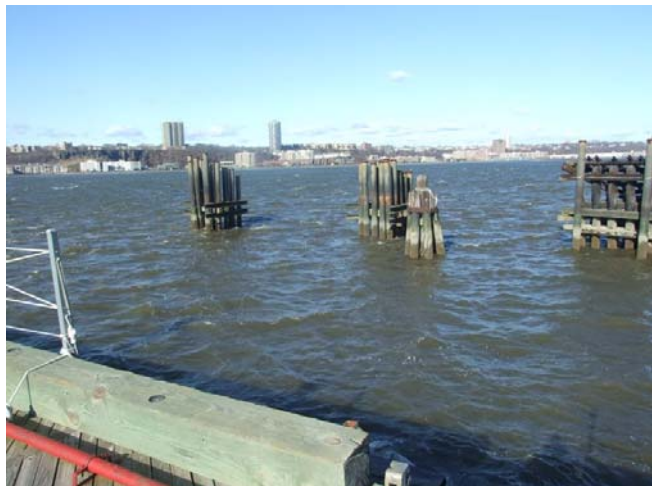
The two outer icebreakers were replaced with steel piling clusters but are still unfinished. There are no peeler rails to divert the ebb flow of ice. Horizontal steel collars were welded around the pilings cluster of each ice breaker above the mean low low water mark. Also, the gap between the first and second icebreaker is the only gap without a dolphin. If a heavy ice flow occurs, the two outboard ice breakers may be lifted out again when the ice piles up under the I-beam collars.

- The two most important ice breakers are unfinished. No peeler rails were installed. The I-beam collars are mounted too high.
- The dolphin between the outboard ice breakers is missing.

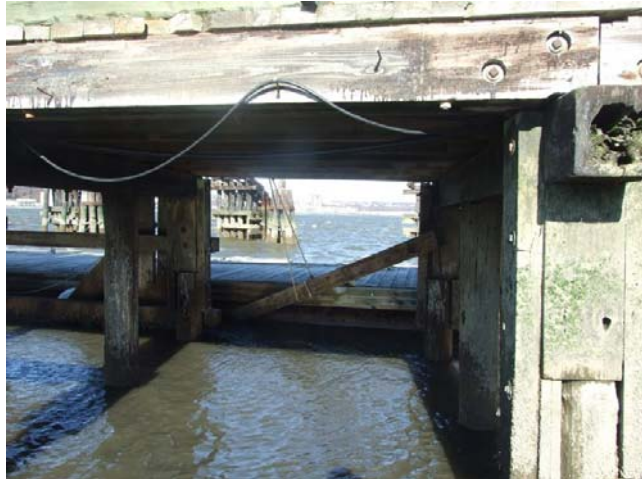
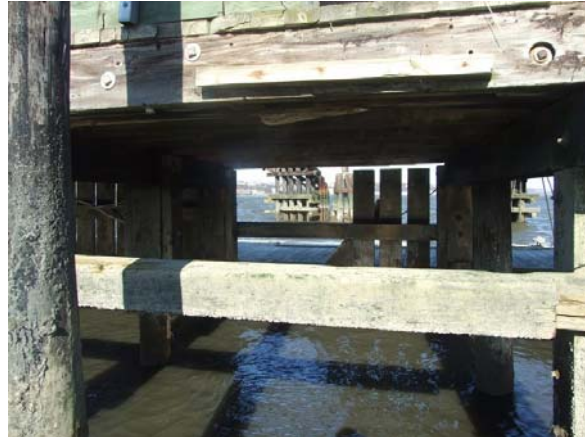
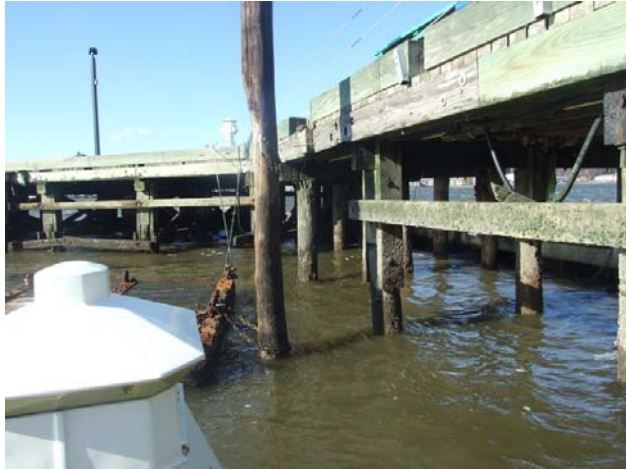
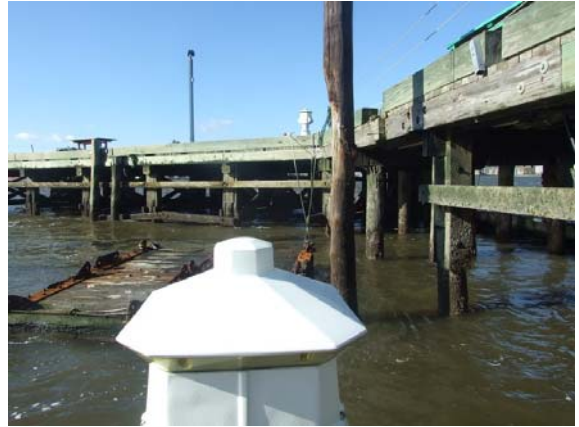
A Dock gaps

Until January, 2008, there was nothing to stop the ebb flow of ice, the stronger flow, from pouring into the Basin through the massive gaps in A Dock planking. Kayakers paddle through some of these gaps. The floating docks that were installed on the north side of A Dock to prevent floes from entering the Basin can be seen in the first photo.

The pictures above show the daylight visible through the gaps of the A Dock head.

- More A Dock planks are missing than present.
- Floating docks and substandard low freeboard, waterlogged camels or WMDs are planned for plugging the two entrances. Floating docks, when used as a first line of defense against ice floes, will eventually be overwhelmed.

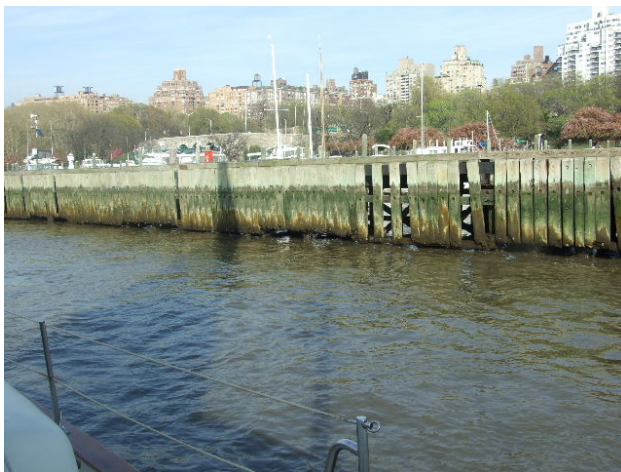
Wave wall

The photo which was taken at a normal low tide shows that the facing planks have been sheared off at the lower whaler or cross beam level. Floes can enter the Basin under the whaler and through the missing facing planks. The loose facing planks, many of which were either lag screwed or through bolted at two of the three whalers, could be torn off the wall and worst case, neighboring facing planks could be torn off creating larger gaps.

- On the wave wall and C dock head, fifteen facing planks are missing and sixteen are loose. Most of the facing planks have been sheared off by the ice to the lower whaler level allowing floes to enter the Basin.

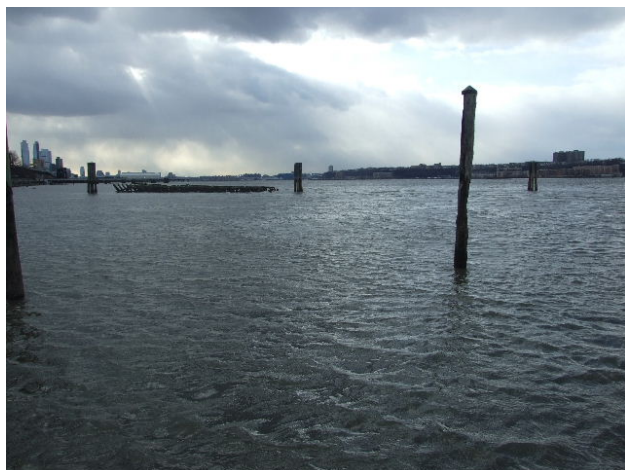
Grounded barges south of Basin

Two barges between the three dolphins shown in the photo were set at an angle south of the Basin to divert the flood flow of ice away from E Dock toward the river. The grounded barges deteriorated over the years and the remaining barge hull with a few ribs is exposed only at lower tide levels..

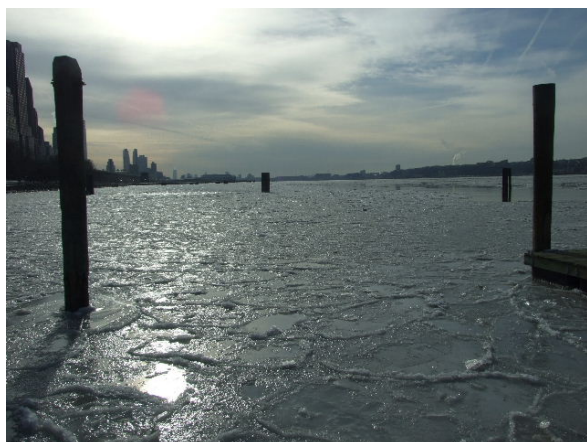
The peak flood current and ice velocity is near high tide at the Basin and at that time the remaining barge is underwater (as seen in this photo) and can't divert the flow of ice.

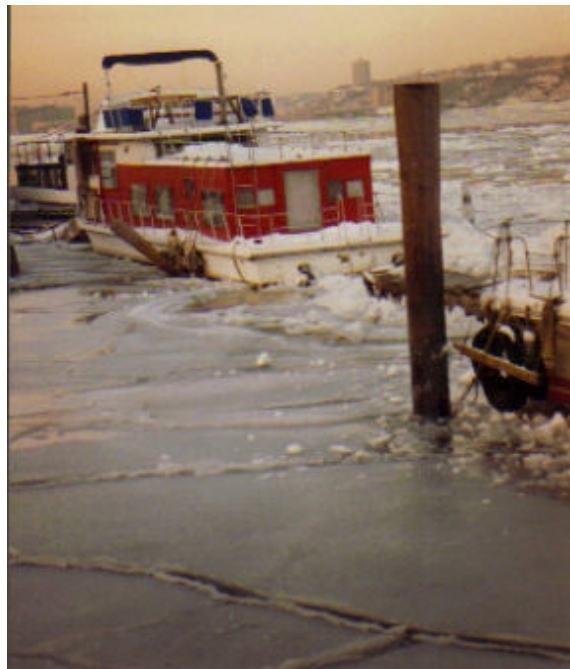
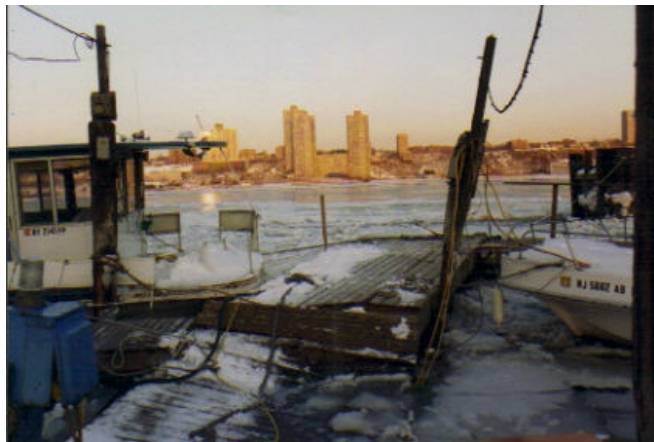
Photo above: Head of E Dock after ice barrier pushed in. Delta Willis' "Delta Queen" bow to the right.

Photo to the left: Delta Willis' "Delta Queen" pushed to the east over its inboard piling. The ice barrier is off her stern.

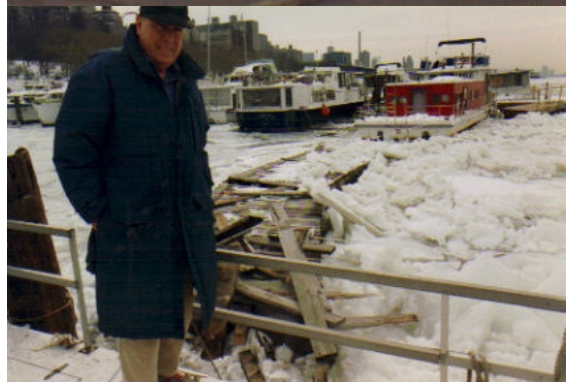
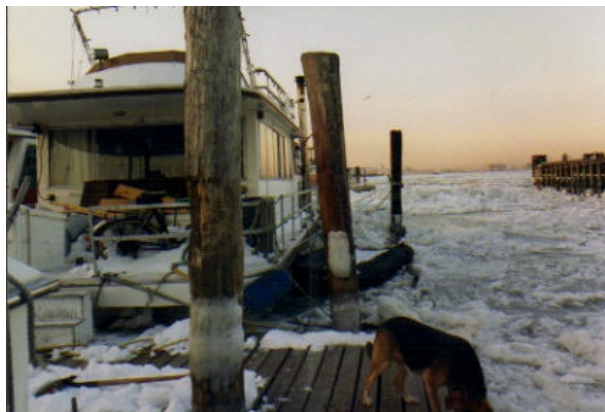
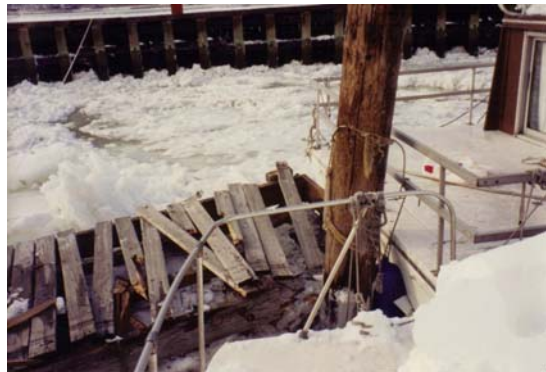
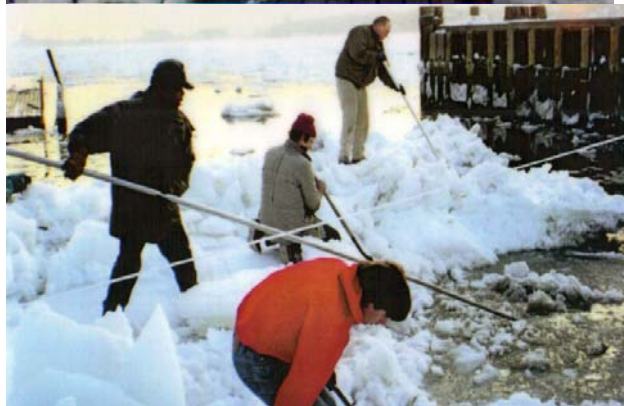
Above four photos are clockwise: 1) Werner Buhner on the stern of "Raquelita" with the floating dock ice barrier bridged to the "Delta Queen", 2) Head of D Dock and bow of "Raquelita" which was pushed onto D dock, 3) Werner, Daron Katzman, Troy (look how thin!), and ?? tearing down the bergs before Parks started charging the bergs dockage and 4) end of floating dock ice barrier and piling, which was between "Raquelita" and Dick DeBartolo's Burns Craft, off "Raquelita's" stern .

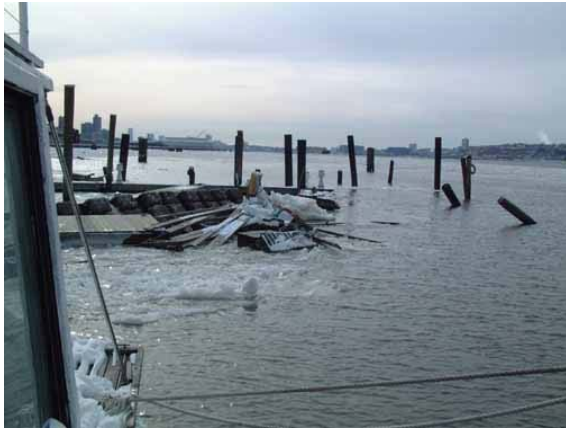
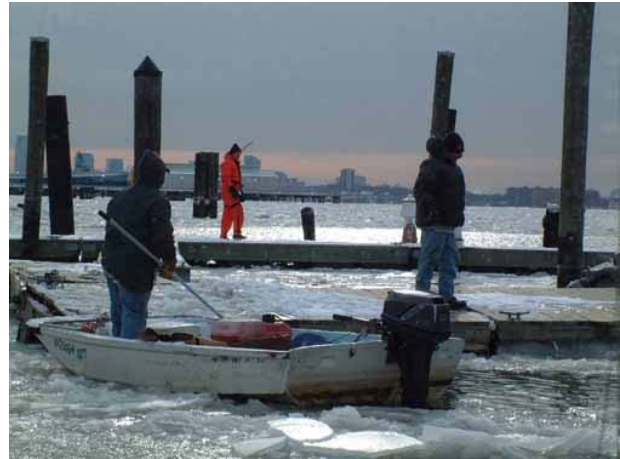
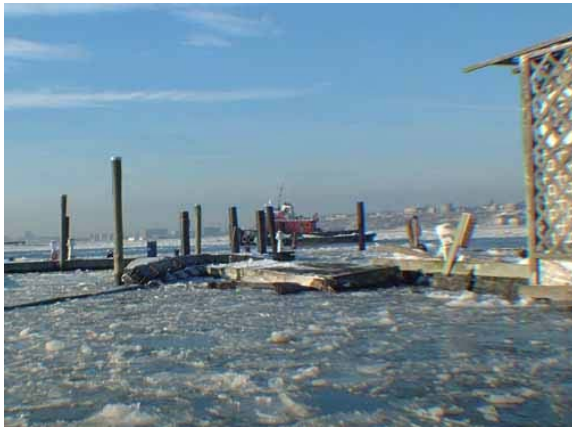
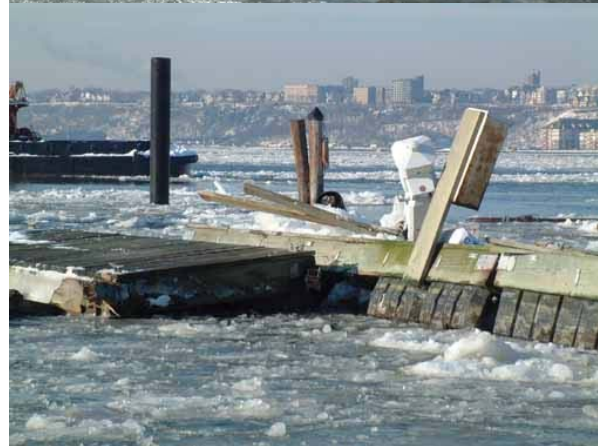
In February, 2004, E Dock was overwhelmed by the ice and pushed almost to D, punching a hole in Dick DeBartolo's boat (on the south side of D). Bob Kilo's quick repair averted a sinking.

Four photos above clockwise: 1) E Dock T crushed, 2) Looking south from D Dock: Troy (always there for an emergency), Greg Smith and Dave??, 3) remnants of E dock, and 4) looking south from D Dock, the tug that Greg Smith and Chris Williamson brought in as a floating boat ice barrier to prevent further damage.

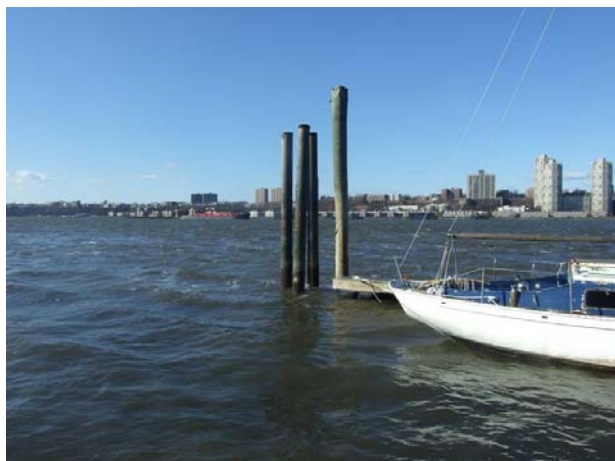
When E Dock was repaired, the dolphin at the south end of the E Dock T, was replaced with a cluster of three stand alone steel pilings with no cabling or I-beams to sister or bind them to one another or together with the one wood piling at the south end of the E Dock T. This cluster or one wood piling essentially anchors the E Dock T – Wave Wall ice barrier which once again is the main deterrent to flood ice flows at the southern entrance.

- The E Dock T pilings cluster is the weak link in flood ice flow protection. If it gives way, E Dock may try to merge with D Dock again.
- The derelict barges are derelict in their duty to take the flood ice flow pressure off E dock.

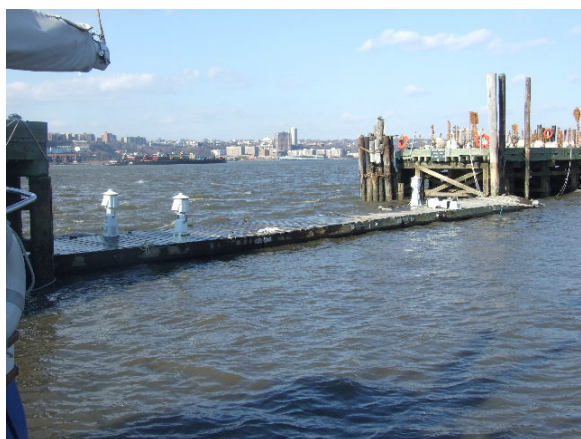
Northern entrance with old floating docks as ice barrier between head of A Dock and head of C Dock.

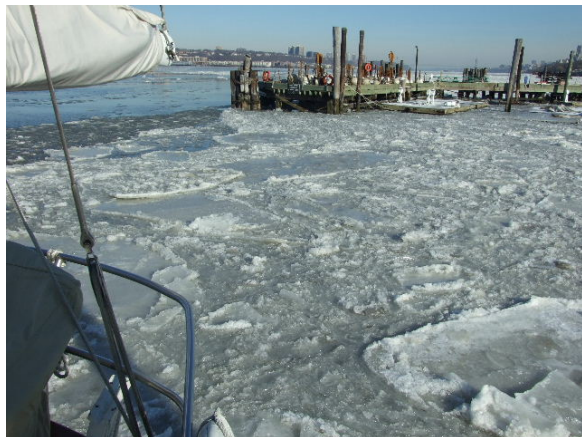
The first significant flow of ice arrived on January 16, 2009 after 6 days of sub-freezing temperatures and Coast Guard ice reports showing the ice was coming. The floes poured in all areas with each tide cycle. Basinites were up at all hours poling ice floes away from their hulls and cursing Parks' new technique of virtual ice barriers such as the one shown in the A Dock – C Dock opening in the photo. Virtual ice barriers are cheap and easy to install but transparent to an ice floe moving at 3 or 4 knots..

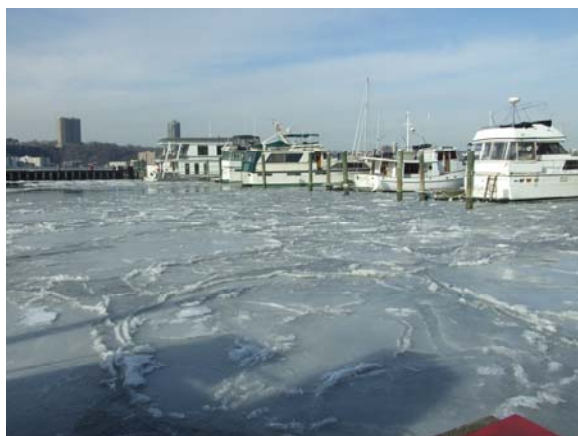
Photo at left shows the south side of C Dock the day after the ice arrived. For three days, the floes were poled and no barriers were installed during the 3-day Martin Luther King holiday weekend. Floating docks were installed the following week across the two entrances. The southern entrance ice barrier consisted of old D dock floating docks and shattered on the flood flow of ice. Once again, floes banged on the hulls. A weary Basinite said, "It sounds like thunder inside the boat." One floe was spotted with bottom paint swatches of red ("Argo"), green ("Raquelita") and blue ("Prelude") . "

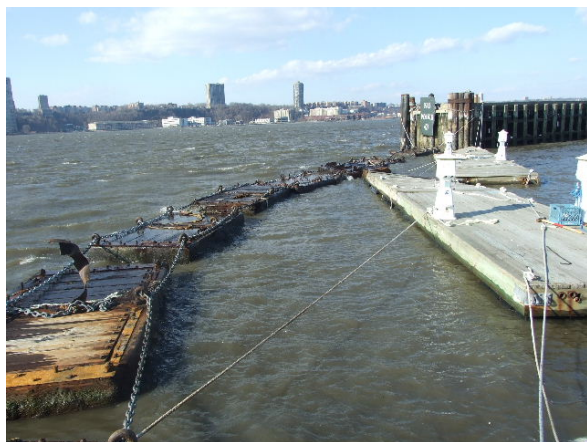
Eventually, the low freeboard camels were chained in place across the southern entrance. Of course, there were no more ice flows the rest of the winter.
